#### Response at Sea

**Cooperation and Coordination**

C.J.Kool (Advisor - Response Organisation North Sea)

9 March 2006

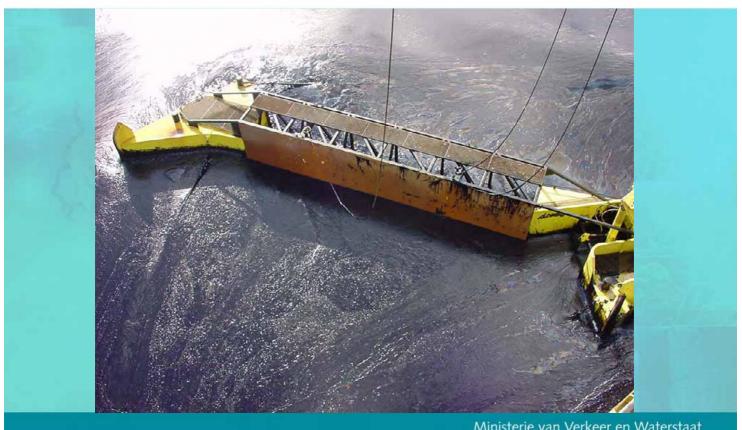
### The Response at Sea the system - sweeping arm

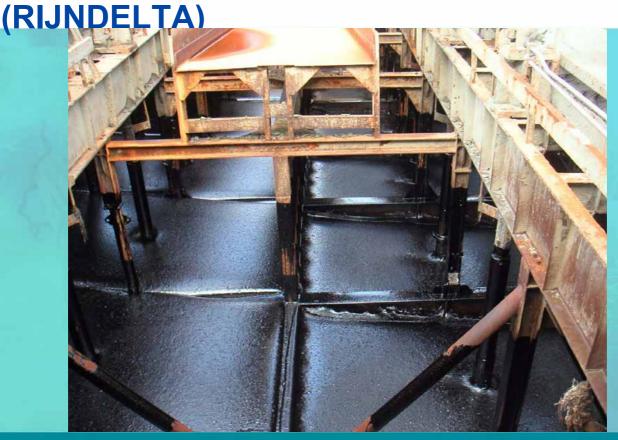
The Response at Sea the system – storage

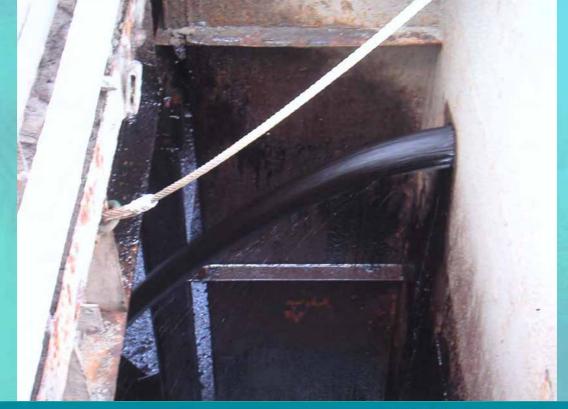
The Response at Sea
Pumping rate 100 m3/hour of one sweeping
arm

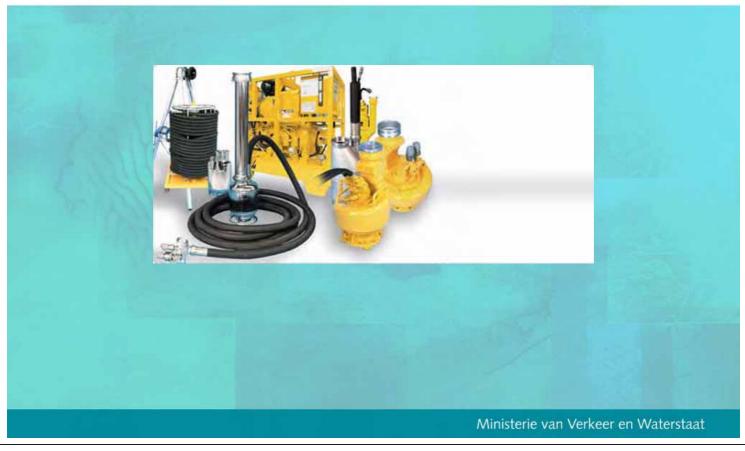
# The Response at Sea the pomp of the sweeping arm

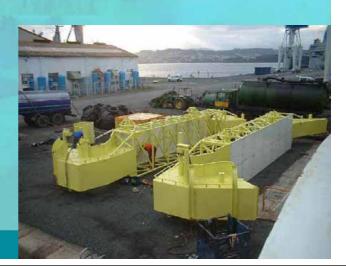
#### The Response at Sea Physical limits in response operations

- Up to Beaufort 6.
- Wave height 2.5 meters
- Angle of attack (between arm and vessel)
- · Length of sweeping arm
- Viscosity of the oil

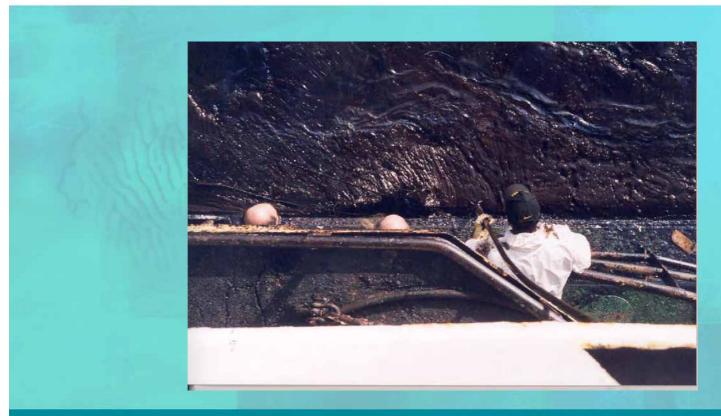
# Response at Sea – layer thickness up to 1 meter

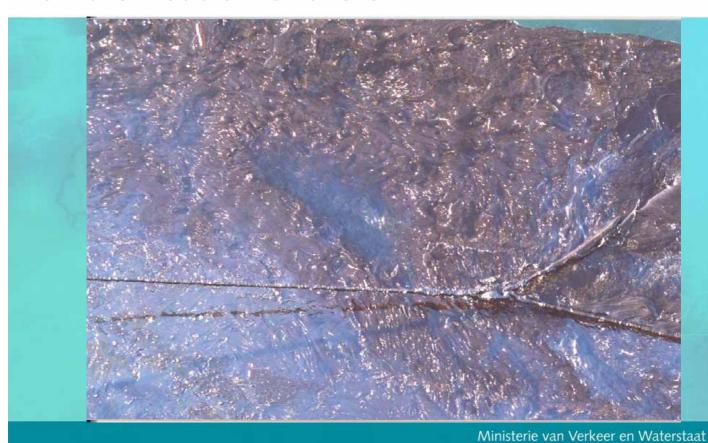
# Response at Sea – emulsification of the oil

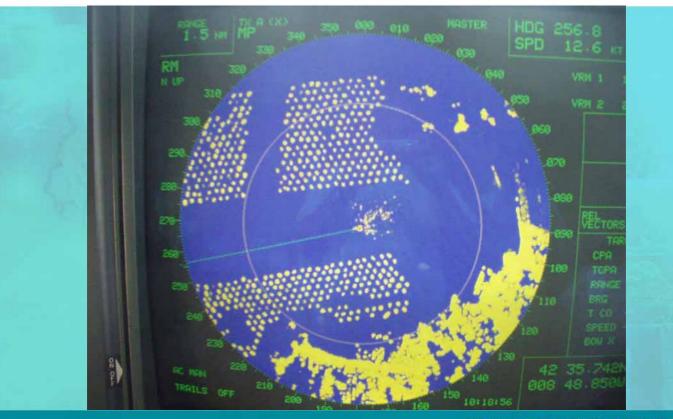
#### Response at Sea – Mussel cultures in the bay of Ria de Arousa on radar screen
