Case study

SUNDARBAN OIL SPILL ASSESSMENT (2014)

Presented by:
Stéphane LE FLOCH

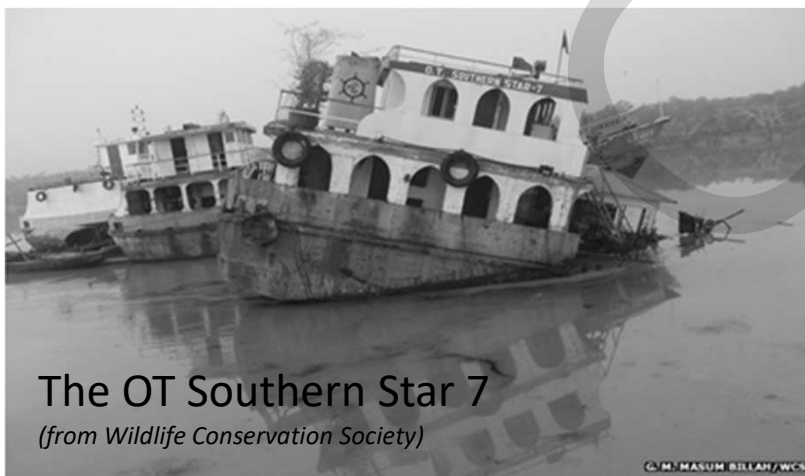
The OT Southern Star 7
(from Wildlife Conservation Society)

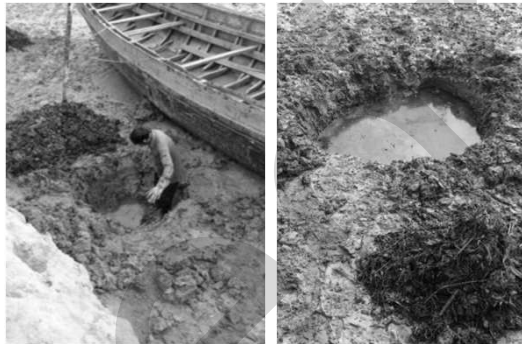
Always difficult to locate buried pollution

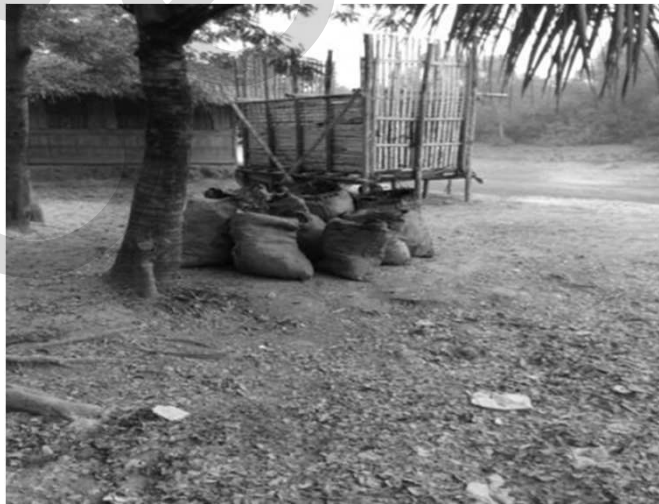
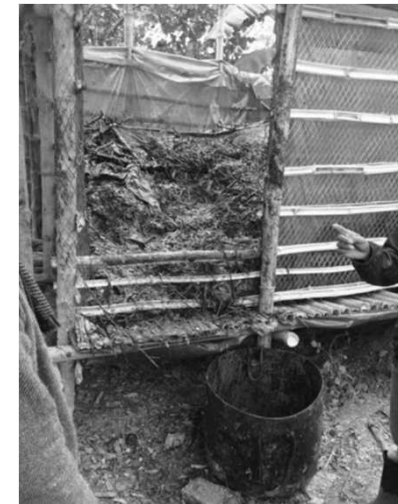
Waste stockage

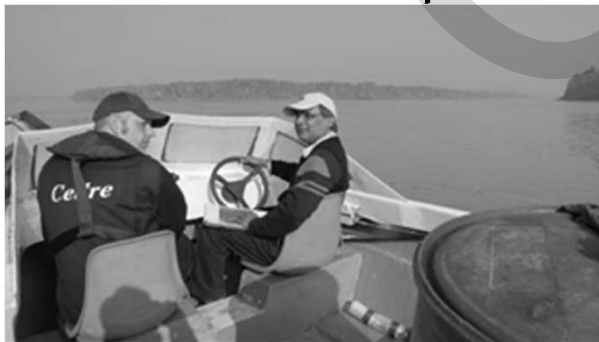
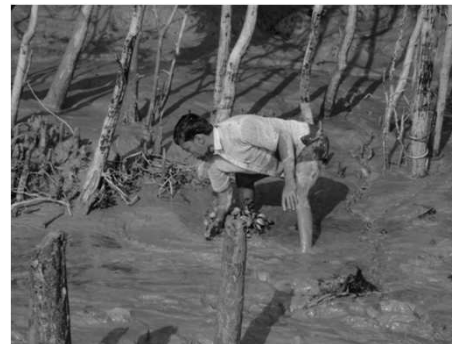
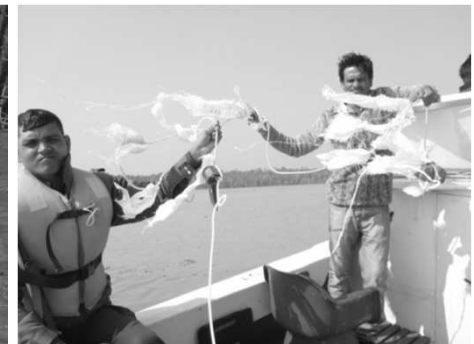
- Survey at low tide
- Visual observation of the shoreline from a speed boat

- Survey at low tide
- Buried versus sunken oil

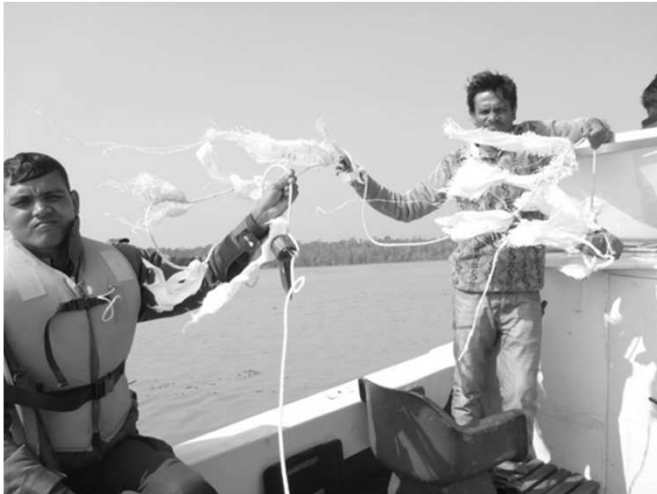
- 20m long rope weighted with 2 weights (<1 kg) one at the extremity and 7 meters before
- Equipped with some stripes of oleophilic material, each 50 cm

- The rope is dragged along a 100m long transect parallel to the shore
- Transects were carried out in particular sites according the initial oiling severity
- Transects were geo-referenced and depth recorded

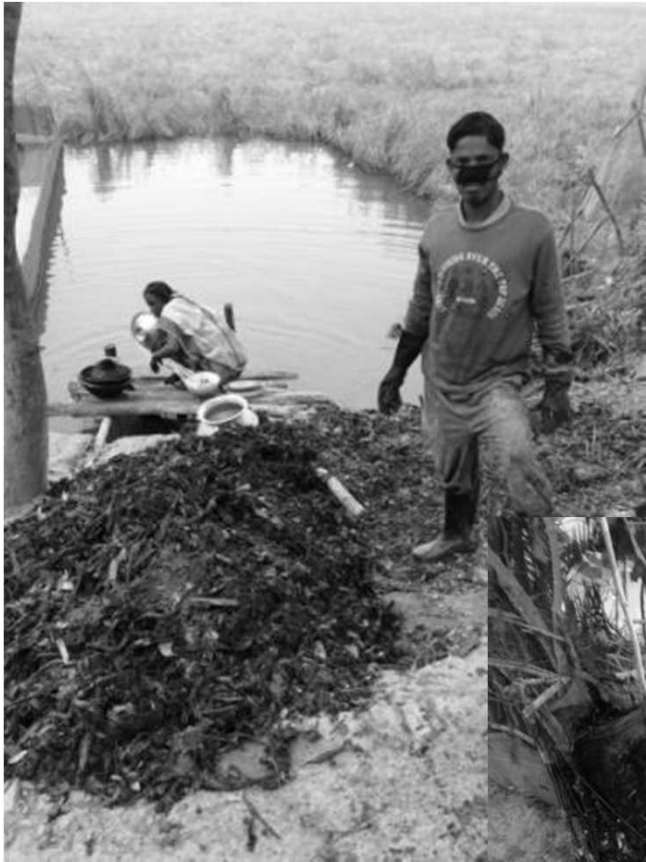
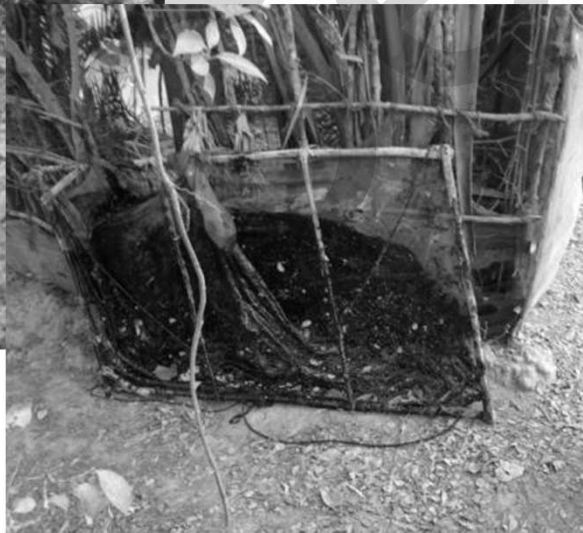
Litres of oil collected (data from Bangladesh Petroleum Company)

Date	Oil collected / litres
12 December, 2014	5,200
13 December, 2014	18,000
14 December, 2014	17,000
15 December, 2014	8,200
16 December, 2014	7,800
17 December, 2014	4,600
18 December, 2014	4,700
19 December, 2014	800
20 December, 2014	1,400
21 December, 2014	500
Total	68,200
