Grounding of bulk carrier *MV Wakashio* in Mauritius

Containers

n°41

AUGUST 2021

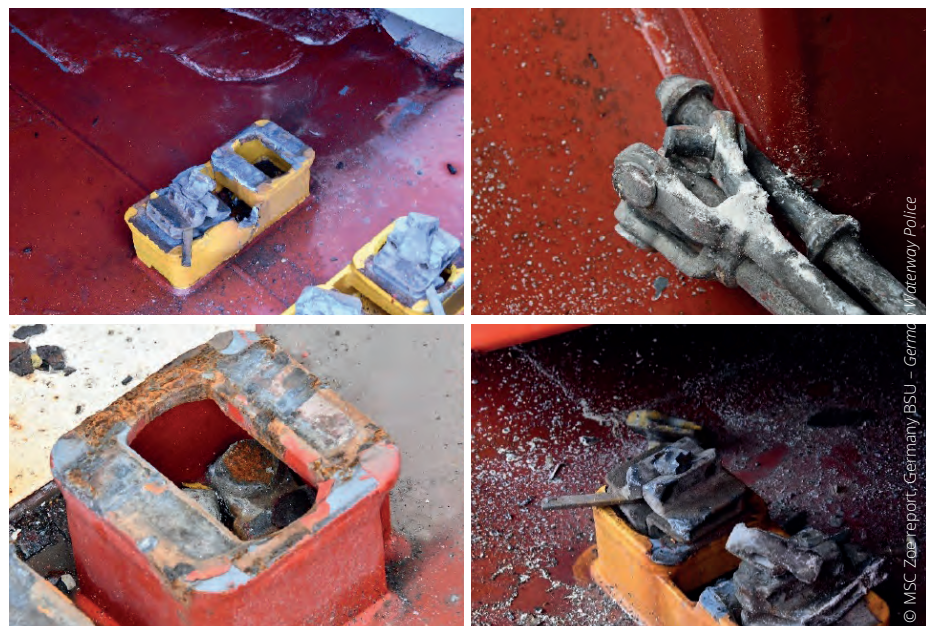
▲ Broken parts: deck fittings, twistlocks, turnbuckles

can no longer withstand the strain. In the case of a ULCS like the *MSC Zoe*, which had phenomenal stability combined with a length of 397 m, the report by the German Federal Bureau of Maritime Casualty Investigation (BSU) indicates that elements of the Code of Safe Practice for Cargo Stowage and Securing (CSS Code) become inapplicable. The provisions of the Cargo Securing Manual may also be inappropriate for very large container ships. Thus, aside from defects of certain automatic or semi-automatic twistlocks, as mentioned in the BEAmer report on the *Otello* incident, in certain sea conditions failure can occur on compliant parts with equally compliant securing.

This leads to the conclusion that container securing and resistance standards should be reviewed to take into account increasing ship size.

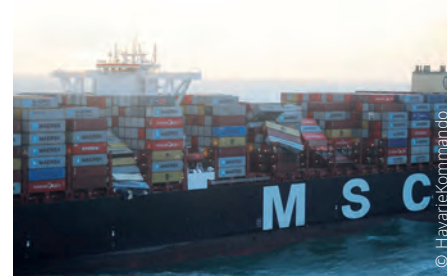
▲ The *MSC Zoe* in the North Sea

At 1 am on the 2nd, a visual inspection with a signal lamp showed that a number of containers had fallen over. Others were hanging overboard. Further investigation was not possible due to the darkness and weather conditions.

At 1:30 am, the roll increased again and the master saw containers collapse and fall overboard. The authorities were alerted and the ship reduced speed and changed course to diminish the influence of the swell and wind. At this stage, the master announced that about thirty containers had fallen overboard.

At daybreak, a tour of inspection was carried out, in particular to locate the containers of hazardous substances. Two of them had fallen overboard, while the third was hanging over the side of the ship. Other containers had also fallen into the sea and the crew observed damage to the lashings, including the tensioners from the lashing rods, twistlocks, hooks and locking pins, etc. Loose parts of the lashings were found on deck. The number of lost containers was re-evaluated several times, finally reaching a total of 270 on the evening of the 2nd. At this stage, the authorities were in possession of the complete cargo manifest but did not know which containers had been

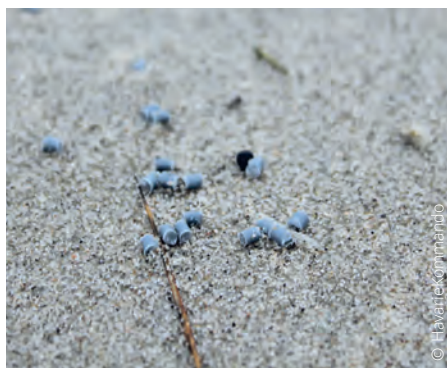
▲ Plastic particles found on Borkum beach

These small beads (4 mm in diameter) were immediately found on beaches following the incident. They were then scattered by the wind, making their recovery particularly difficult.

The second contained 1,400 kg of lithium-ion batteries (class 9). To our knowledge, it was not found. Finally, the third container was loaded with 22.5 tonnes of expandable polymeric beads (Industrial Plastic Pellets, IPP). These beads are considered hazardous (class 9) due to the fact that they are manufactured in such a way that they can release pentane (a few percent) during transport, which can generate a flammable atmosphere. This type of bead has already been identified as a cause of major explosions.

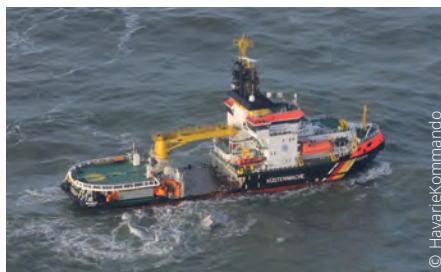
▲ German vessel *Neuwerk* conducting a search operation

Searches were also carried out from vessels equipped with multibeam sounders. Initially, search operations focused on the southern lane of the TSS, then were extended to the area between the lane and the coast.

In total, more than 6,000 objects were identified on the seabed and were plotted for each km². Of course, not all of these objects were from the *MSC Zoe* and it would not have been conceivable to bring up everything found. Additional observations were made using a ROV equipped with a video camera to attempt to distinguish the debris from the *MSC Zoe* from other debris.

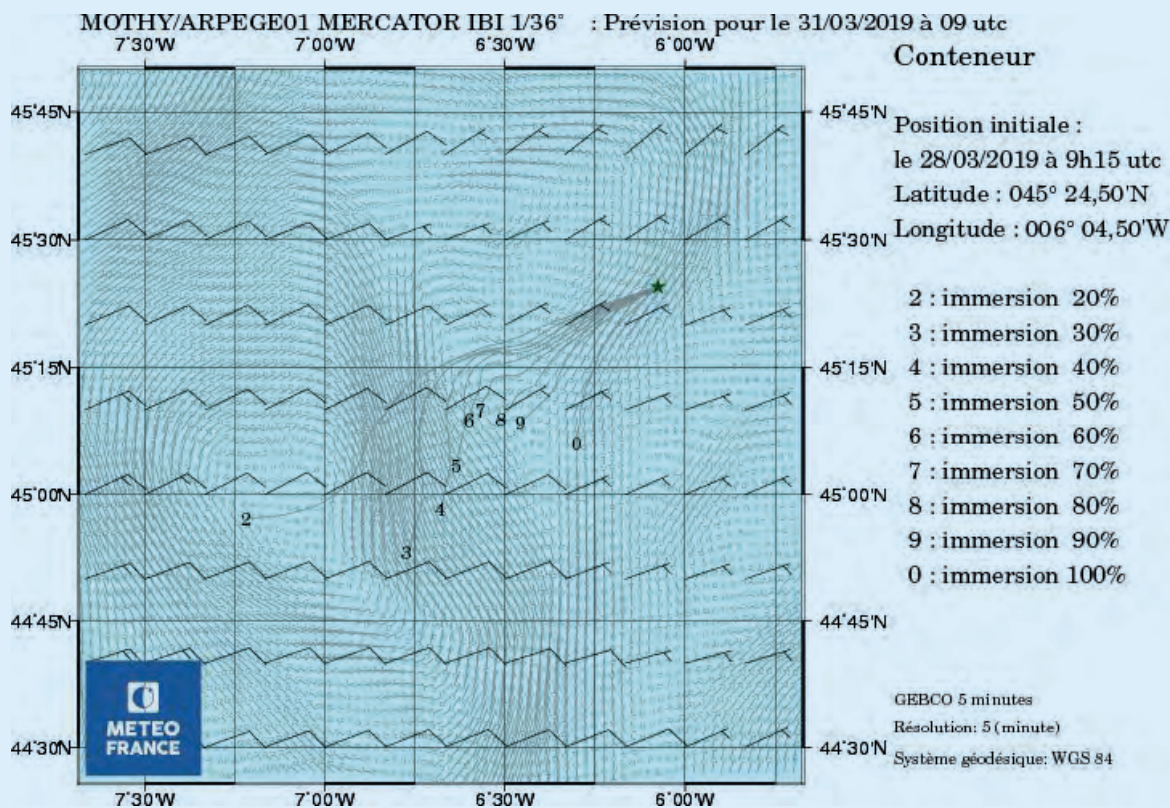
^ Mothy forecast at +72 hours for a drifting container lost from the Grande America, Bay of Biscay, March 2019. The numbers on the map indicate different possible immersion level hypotheses.

Mothy's "containers" module has been operational since March 1998 and can be activated on demand 24/7 by a marine forecaster at Météo-France's National Forecasting Centre. It has since been activated many times and has led to the

successful recovery of containers lost overboard. Its accuracy has been enhanced over time as the accuracy of environmental data (winds and currents) has improved. A recent example of a ma-

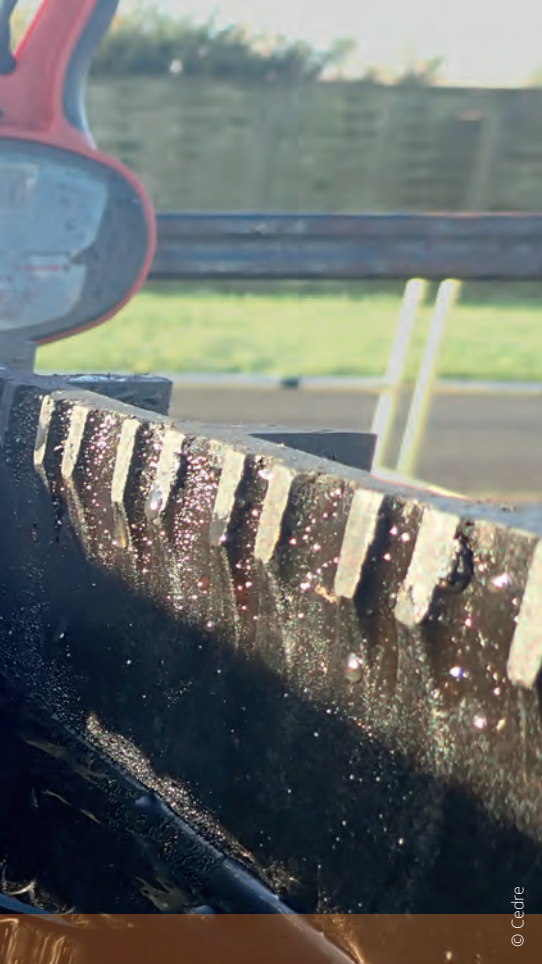
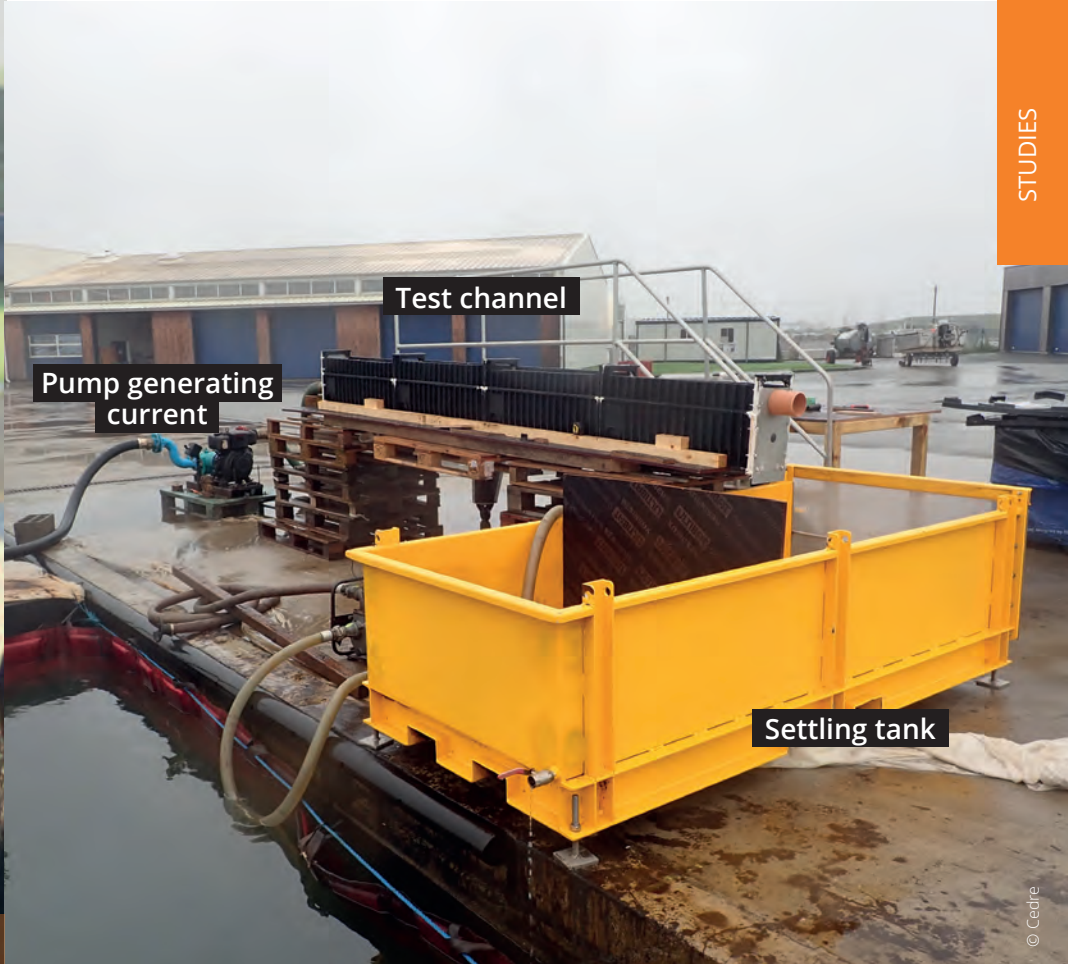
▲ Installing the filtration testing system

The table below shows the different filtration conditions tested in this study. To simplify the test matrix, certain combinations that were assumed to have poor effectiveness were eliminated: insufficient filtration capacity for light products (straw for a diesel spill) or, on the contrary, excessive filtration capacity for heavy

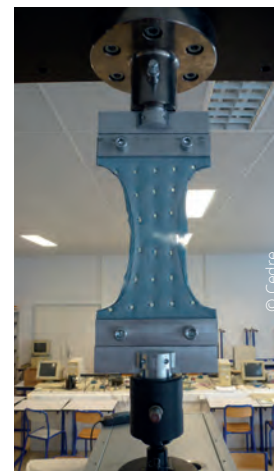
▲ *Sorbent sample in the traction test bench*

- The oil sorption capacities can be correlated with those obtained for a viscous chemical and are significantly different from the results obtained with a low viscosity chemical.
- A loss of resistance of approximately 40% was measured for chemical-soaked sorbents.

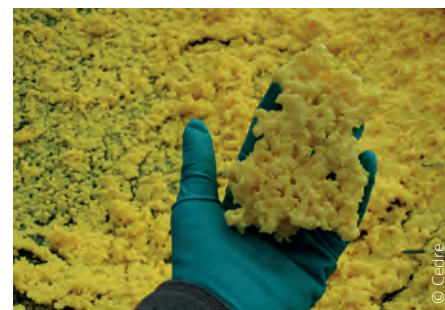
△ Crust of sulphur following a release of molten sulphur into Cedre's deepwater test tank

offshore environments (large quantity of water) and fast-flowing rivers. Sulphur may also be present at the water surface in the form of dust particles or even a solid slick in the case of a release on a partially submerged solid structure (e.g. ship's hull or quay). On the bottom, cooled molten sulphur is present in the form of different sizes of beads which may be discrete; these beads may be dispersed by the current or, on the contrary, merged together to form a crust.

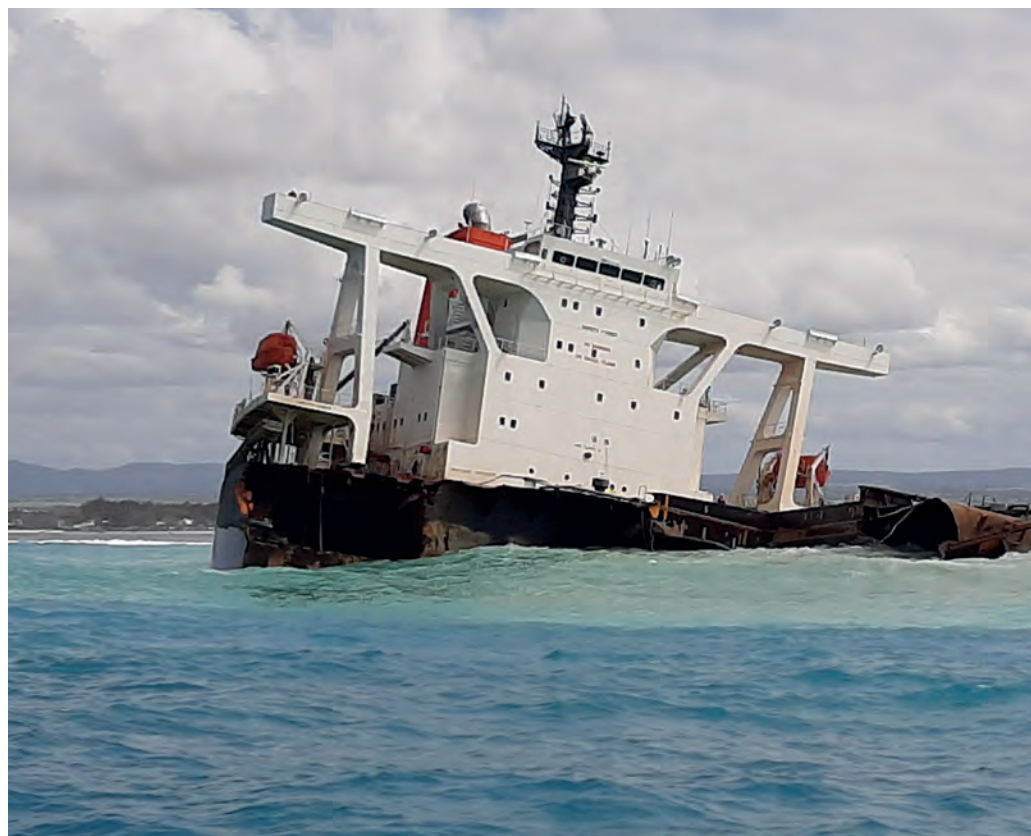
▲ Wreck of the *Wakashio*, photo taken on 21st August 2020

A few days after the vessel ran aground, the Mauritian coastguard detected small-scale oil leaks in the lagoon and laid spill response booms around the *MV Wakashio* as a protective measure. Personnel and equipment were dispatched and, by 3rd August, experts from SMIT (salvage), two tugs and one supply vessel sent by the shipowner as well as a tug (*VB Cartier*) provided by the French authorities were on site. Despite the resources deployed, it proved impossible to refloat the vessel.

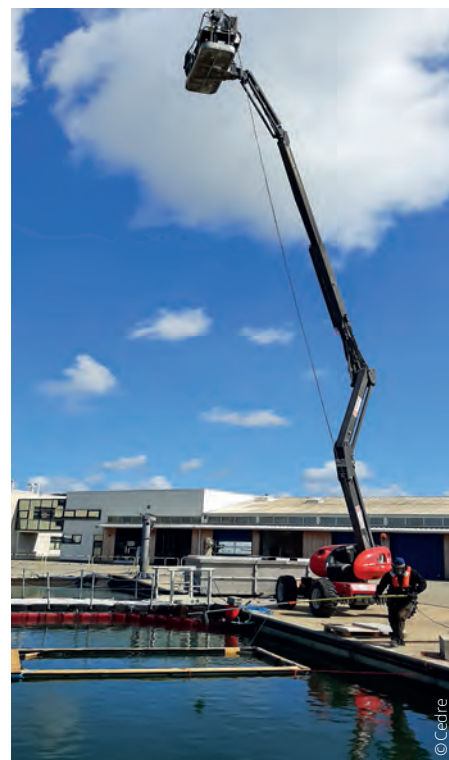
The tests conducted at Cedre confirm the potential of these hyperspectral cameras for the detection and characterisation of chemical slicks drifting at sea. These tests argue in favour of open sea trials under the responsibility of the French Navy and with the logistical support of CEPPOL to assess the performance of the cameras in real conditions, and in particular, to evaluate the effect of wave action on their performance.

^ Tests in Cedre's outdoor tank

sen because they are very often transported by chemical tankers. The results obtained show that colourless slicks were accurately detected and that it was possible to observe differences in response between chemicals. This last point suggests the possibility of tracing the chemical nature of the product forming a slick on the water surface.
