**CENTRE OF DOCUMENTATION, RESEARCH AND EXPERIMENTATION ON
ACCIDENTAL WATER POLLUTION**

Sea & Shore Technical Newsletter n°41

2015-1

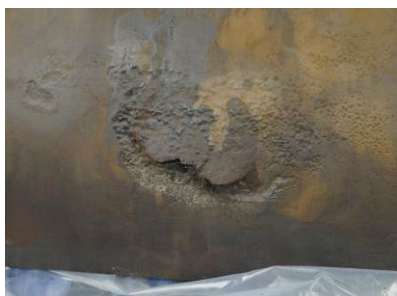
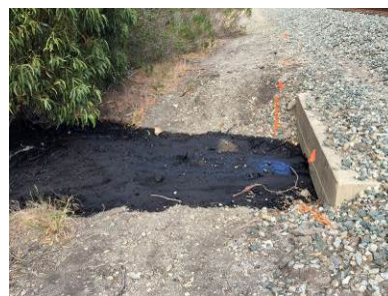
Left: Close-up of the breach in the line (Source: PHMSA); Right: Visible crude oil leak at a drainage culvert (University of California Santa Barbara)

A breach opened up at a point of corrosion in the line, where the wall thickness had decreased by around 75%⁵. The pipeline (24 inches/61 cm in diameter and constructed in 1987) transports crude oil from nearby extraction wells to storage facilities in southern California.

The incident occurred around 100 m inland. The crude oil rapidly reached the Pacific coast via a drainage culvert running under the coastal highway and flowed out of an outfall at the northern end

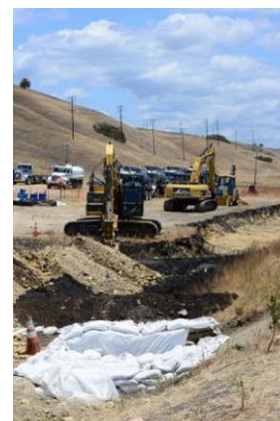
22/05/2015: Excavating soil near to the spill point (Source: USCG)

At the spill source, two days after the spill, the operator began to flush out the culvert which passed under the highway, then excavated the soil to reveal the leaking section of pipe and remove the polluted soil.

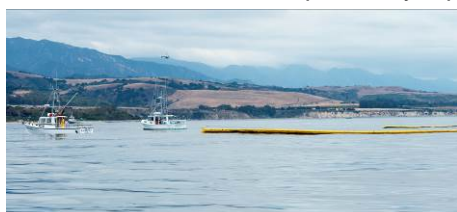
21/5/15: Pair trawling of floating booms off Santa Barbara (Source: USCG)

Inshore, over 15 vessels were immediately mobilised to recover the floating oil using containment booms and skimmers. These vessels included fishing boats fitted out as Vessels of Opportunity (VOOs), pre-contracted by the local specialised company Clean Seas and whose crew members received ad hoc training in containment and recovery operations Hazardous Waste Emergency Operations Response – HAZWOPER – Training⁹.

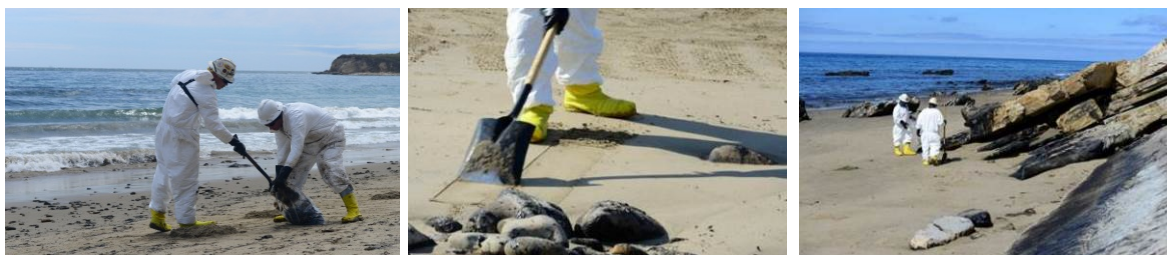
Manually collecting various forms of crude oil deposits (tarballs, patches, etc.) on substrates close to the spill (near Refugio State Beach), 2 days (left), 3 days (centre) and 4 days (right) post-spill (source: USCG)

Clean-up operations included the pumping of pockets of fluid crude oil (contained by booms or trapped in dips in the ground), using vacuum trucks, in some cases together with skimmers, and manual collection/scraping of deposits left along the high tide mark, using lightweight tools (shovels, rakes, etc.) or sorbents.

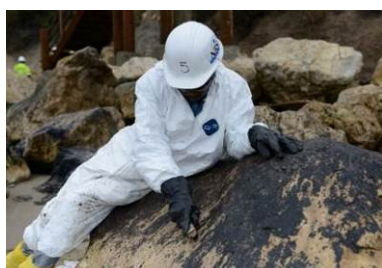
Left: Evacuating lightly oiled sand in sacks (Refugio State Beach, 23rd May); Above: scraping splashes off rocks (Source: USCG)

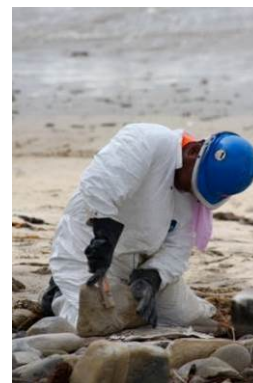
11/6: Final clean-up of stones
(Source: City of Goleta)

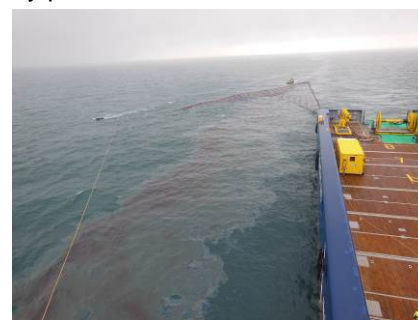
Deploying the MOSS Sweeper 50 from the Stril Luna (Source: NOFO)

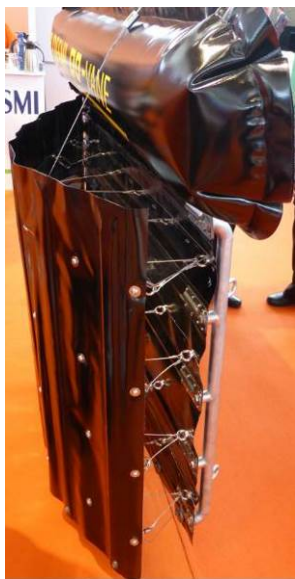
The system can be towed by 2 boats operating in a pair trawling configuration, or by a single boat with a jib arm or paravane.

In this respect, the Danish firm launched its own paravane in 2015. Originally marketed as the Ro-Vane, it is now christened the Ro-Kite, due to how it operates: the device is powered by a structure in the form of a vertical wing, similar to a kite. With a draught of 2.20 m, the "kite" part is supported by vertical steel bars and is buoyed by a 3 m-long inflatable chamber.

The Ro-Kite 1500 can be dismantled/folded and is designed to be used together with the Speed Sweep 1500, or more generally in the conditions for which this boom is intended (coastal waters).

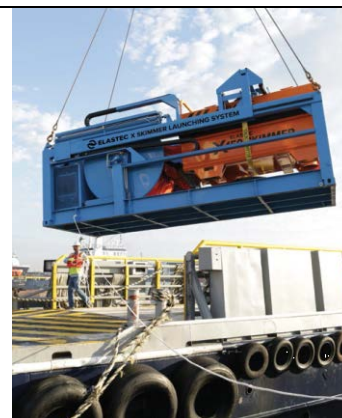
The X150 Skimmer Launching System being crane-lifted onto a vessel's deck (Source: Elastec)

The integrated deployment system is remote controlled and includes the launcher, the X150 skimmer, boom and reel, a paravane and a power pack. The hydraulic and discharge hoses are built into the boom. All the components are stored within a robust steel frame which fits into a 20-foot container for storage and shipping. The full system (excluding container) weighs just over 7 tonnes

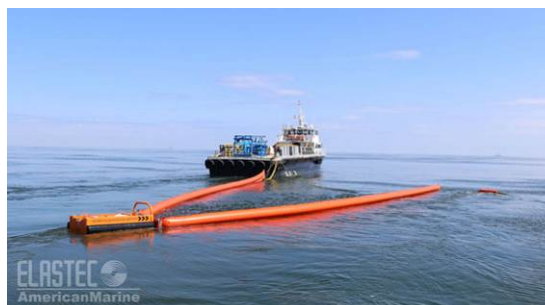
View of the system, deployed from a non-specialised vessel (Source: Elastec)

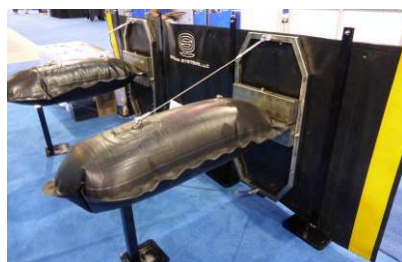
Left: The floats positioned on the outside of the ORS-1000's deflection boom arms (Source: Cedre); Right: The 2 rows of weirs concentrating the oil at the apex of the system (Source: Ocean Systems LLC)

The boom itself has a draught and freeboard of 60 cm and is flat, a shape considered more efficient than a cylindrical chamber for funneling the oil to the apex. Its buoyancy and seakeeping performance (articulation and stability) are provided by a series of inflatable cylindrical floats (L=1.20 m; Ø=40 cm), attached perpendicularly to the outside edge of the boom (i.e. parallel to the water surface) and fitted with counterweights.

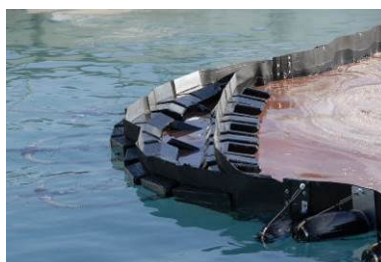
An external tension line runs the whole length of the boom.

The system's nameplate recovery rate is almost 230 m³/hour (1,000 gallons/minute), with an oil recovery efficiency of 90% (up to a maximum of sea state 3).

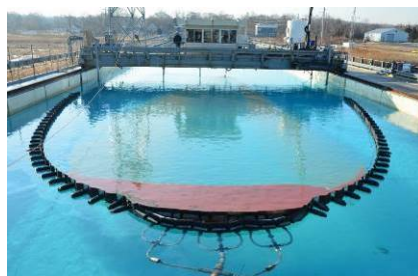
Tests on a prototype at OHMSETT (Source: Ocean Systems LLC)

These estimations are based on the results of series of tests carried out at OHMSETT's testing facilities on a one-third scale prototype. The conditions simulated a current speed of 1.6 knots and a wave height of 1.25 m at full scale.

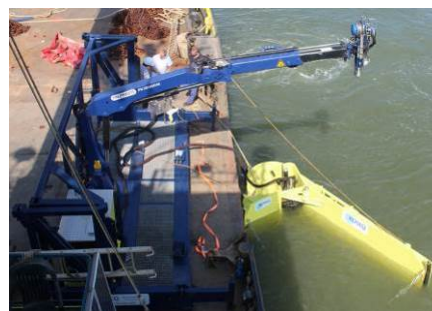
Deploying the Koseq Compact 502 (Source: Koseq)

It is based on the same sweeping arm principle but in smaller dimensions with a 5 m-long arm, with a weir skimmer at the base, coupled with a submersible pump (Marflex MSP 100) with a nameplate capacity of 150 m³/hour. The skimmer can be an oleophilic brush (like the larger models), disc or drum skimmer.

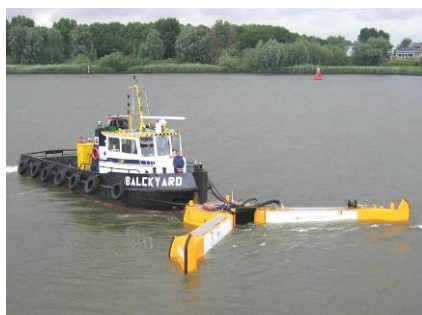
The Victory Oil Sweeper operated by a push-tug (Source: Koseq)

This system is composed of 2 sweeping arms positioned in a V shape designed to be pushed by (or attached alongside) a workboat. By adjusting the angle between these arms, the swath width can be adapted according to the speed of travel.

At the apex of the system, the collection chamber is equipped with 2 Marflex MSP 150 pumps (with a nameplate capacity of 2x360 m³/hour), bearing in mind that the weir can be replaced by oleophilic modules (belt or brushes), or even a conveyor belt for collecting floating debris (for cleaning harbours).
