**CENTRE OF DOCUMENTATION, RESEARCH AND EXPERIMENTATION ON
ACCIDENTAL WATER POLLUTION**

Inland Waters Technical Newsletter n°26

LTEI 2016

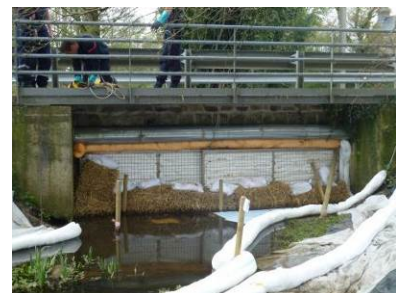
*Filter system (straw and sorbents in a wire structure) 1.5 km downstream of the leak
(Source: Cedre)*

- 1.5 km from the leak point, at the confluence with the Brivet, a major preventive system was set up. This two-fold system included a shore-sealing boom, completed with bales of straw and sorbent booms laid both on the water body and inside a wire structure. The wire structure was backed up against a small road bridge, where its role was to filter residual oil while not disrupting the flow. Pumping and storage equipment was pre-positioned here and the site was supervised 24/7 by the fire brigade and refinery fire-fighters.

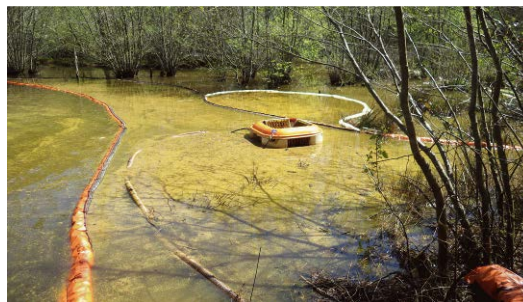
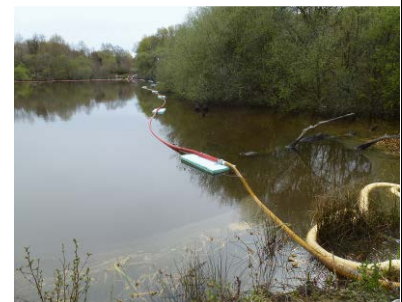
*Photos: Major accumulations of biodiesel trapped on the edges of the wooded banks, with difficult access (left); Floating hose to transfer the fuel collected from the downstream shore to the upstream shore of the second pond (right)
(Source: Cedre)*

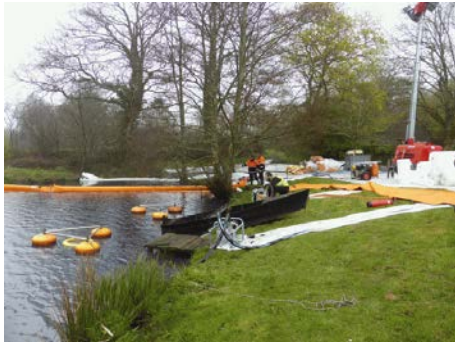
First pond: containment using floating booms and sorbent booms; recovery using mechanical weir skimmers. Note the ground protection with geotextile. (Source: Cedre)

On the water, the free diesel was contained by laying light floating booms, sorbent booms and skirted sorbent booms.

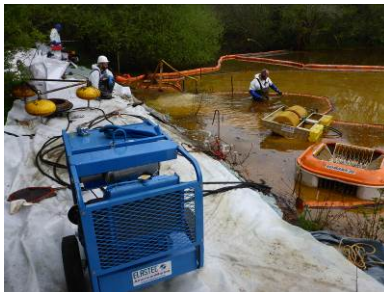
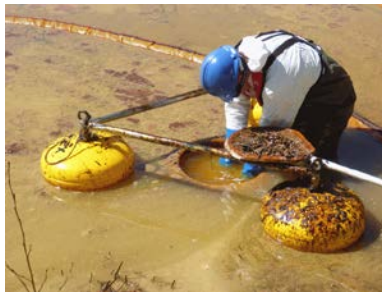
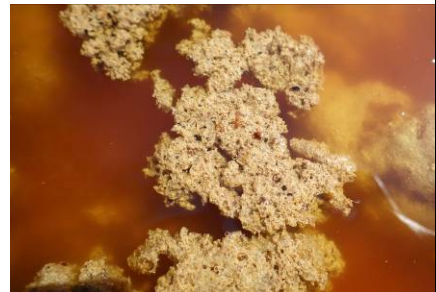
Area of natural accumulation of free pollutant (northern wall of second pond): deployment of oleophilic drum and disc skimmers (left); manually unclogging a Mini Foilex weir skimmer (centre) clogged with weathered biodiesel, amalgamated with plant debris (right); (Source: Cedre)

From the first week of weathering in the natural environment, the biodiesel took on a major transformation with phase separation, emulsification and formation of an extremely adhesive residue which formed amalgams. For a few days, these amalgams prevented both mechanical skimmers (clogging of weirs) and oleophilic skimmers from functioning correctly.

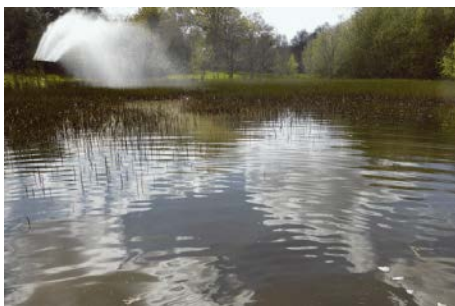
Low pressure flushing of fuel trapped in vegetation (horsetail) (Source: Cedre)

The contractor *Le Floch Dépollution* deployed various specially made low pressure systems designed to suit the conditions in each area: flooding using a "manifold" with a low pressure flow rate of 100 m³/h; perforated pipes laid on the ground; flat jets or sprinkler jets with varied ranges.

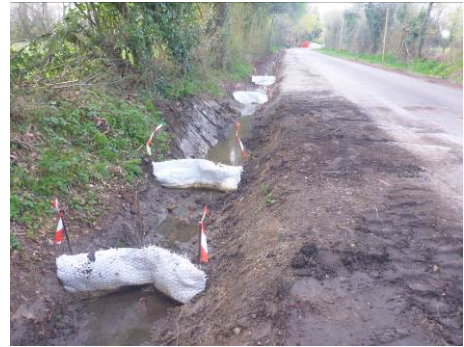
Series of custom-made devices (sorbent strands and wire mesh) to capture the residual pollution along a roadside ditch which the fuel had entered (ditch purged and scraped prior to installation of the devices) (Source: Cedre)

We also note that, for several kilometres downstream to Brivet, similar filtration/sorbent devices were fixed in place in the watercourse, some of which were left in place once clean-up operations had finished as "sentry points" to check that no residual contamination remained downstream of the clean-up sites.

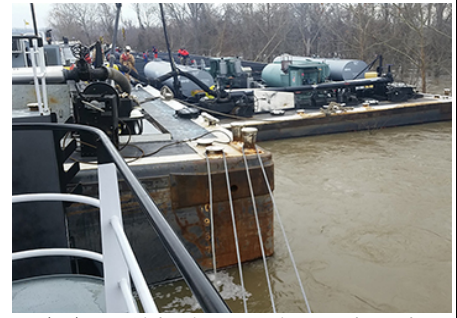
23/01/2016: Lightering operations on the tanker barge MM-46 (pumping and transfer to a barge brought alongside) (source: USCG)

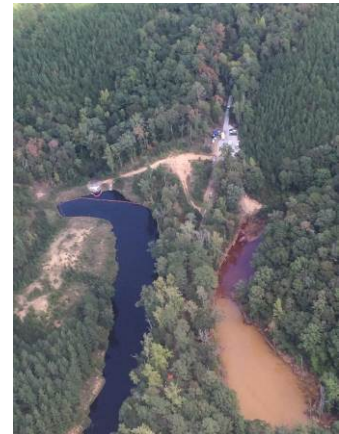
18/09/2016: view of the contaminated man-made pond (right) 9 days after the spill. The second pond (left) was not affected (Source: US EPA).

Due to its natural containment in the man-made pond, the oil, which was light with a high volatile compound content, required atmospheric contamination monitoring to be rapidly implemented. To do so, a company was contracted by Colonial to control the risks (explosiveness and toxicity) for responders.

The implementation of response operations in the ponds was therefore almost entirely prevented for the first two days and heavily restricted over the following days due to high concentrations of Volatile Organic Compounds (VOCs) around the accumulations of petrol. Nevertheless, no inhabitants were

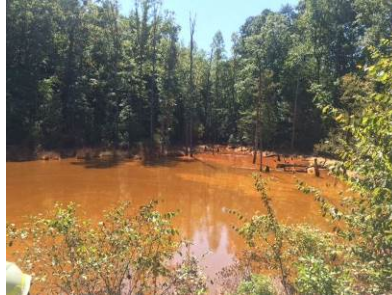
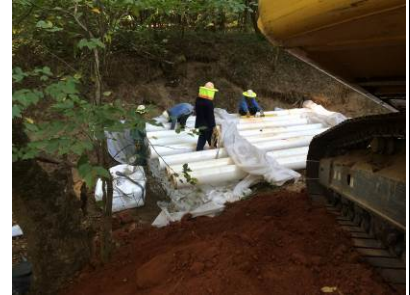
Left: Areas of high concentrations of petrol in the contaminated pond: Right: Construction of bunds with underflow pipes at a natural weir in the pond (Source: US EPA)

This was implemented by constructing bunds with underflow pipes at the outfall of the natural containment areas.

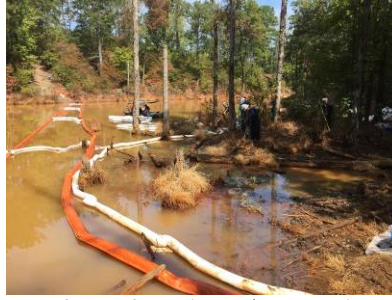
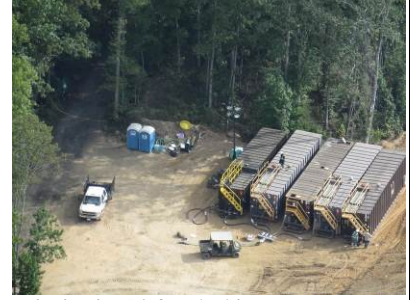
Left: Petrol containment/recovery sites along the banks; Right: Liquid waste storage in Frac Tanks, to the rear of the clean-up sites (Source: US EPA)

At the skimming/pumping sites on the water, liquid waste was collected in collapsible tanks. It was then transferred by vacuum trucks to intermediate storage areas, set up behind the clean-up sites and composed of Frac Tanks⁹ to store and settle the large quantities of effluent on site.

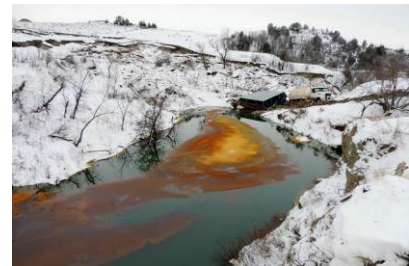
10/12/2016: Oil spill naturally contained in Ash Coulee Creek (Source: North Dakota Department of Health)

Clean-up actions included recovering floating oil by pumping, after rinsing the banks, and a few controlled in situ burning operations. A fortnight after the incident was reported, the oil company announced that it had recovered around 300 m³ from Ash Coulee Creek.

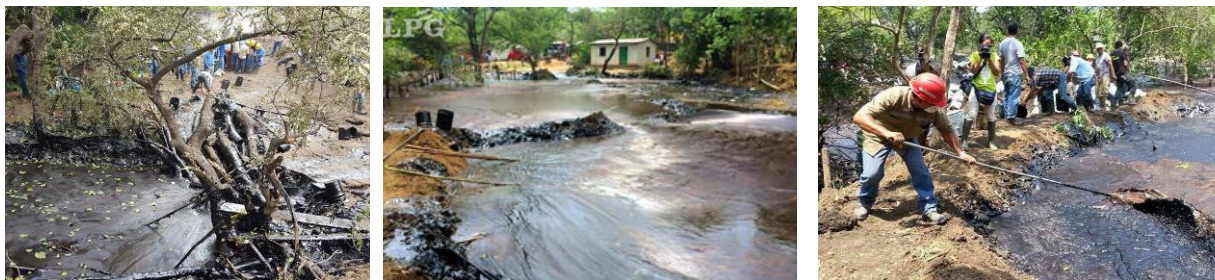
Left and Centre: Bed of the Paz River coated in molasses (source: MARN); Right: Manually recovering deposits of molasses along the banks (source: J. Henriquez / <http://ecoviva.org>)

Although the spill was reported by MARN with a few photos and videos posted on various web media (Twitter, [YouTube](#) channel, etc.), little information was provided on this incident in terms of spill response actions: at the least, various photos suggest that manual techniques (collection, scooping, etc.) were used to recover part of the product, which became viscous once it had cooled down. Around 12 days after the spill, the Ministry announced that 95% of the volume released had been recovered and that the physical and chemical properties of the water had returned to normal.

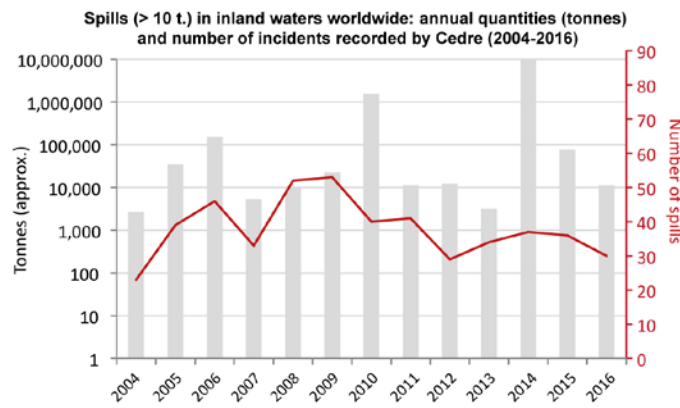
Figure 1

These incidents represented a total quantity of around 11,300 tonnes of oil and other hazardous substances spilt (Fig. 1), an estimation lower than the annual median expressed for the period 2004-2015 (around 17,350 tonnes).

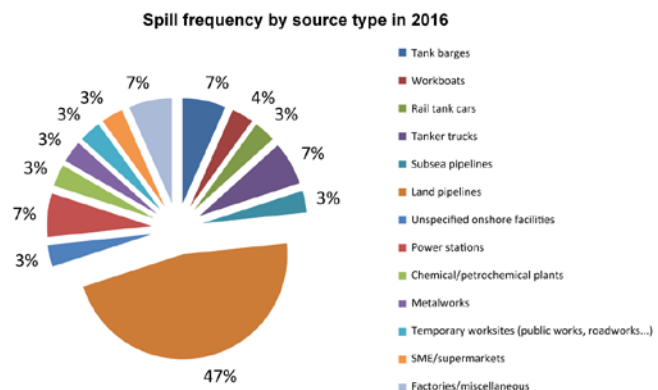
Figure 2

The other types of sources identified in 2016 (**factories**, various **SMEs**, etc.) were involved in less than 5% of significant spills during the year. In approximately 7% of cases, the spill was connected to **unspecified onshore facilities** (Fig. 2).

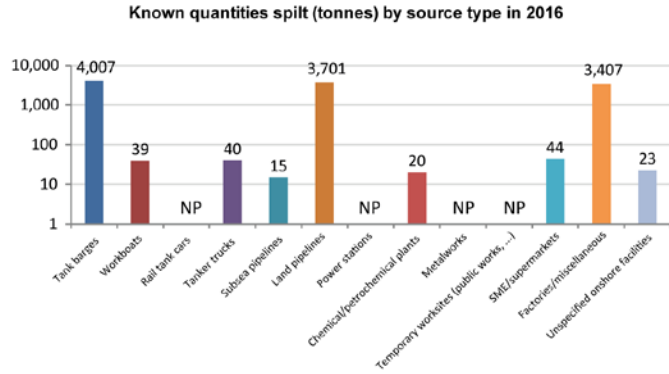
Figure 3

Bearing in mind this reservation, we note nevertheless the 35% share of tanker barges (around 4,000 tonnes), mainly due to the sinking of a barge on the Mississippi and the loss of its cargo of liquid fertilisers.

The second visible share is that of **land pipelines**, representing around 33% of the total quantity spilt, due to the high frequency of incidents on such structures (see above), generally causing spills in excess of 100 tonnes, or even 1000 tonnes (as was the case of the spill of nearly 1,200 m³ of petrol from the Colonial Pipeline in the US in September, which alone accounted for nearly a third of this share).

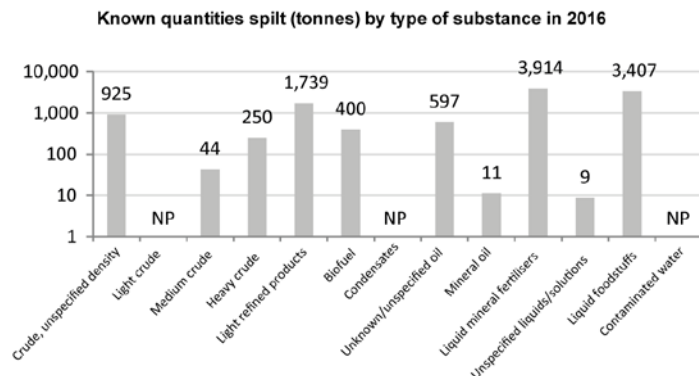
Figure 4

Chemical spills represent approximately 35% of the total quantity spilt in 2016, a share relatively close to that of oil. This share is almost entirely dominated by the **liquid mineral fertilisers** category, due to a single spill of over 3,900 m³ of urea and ammonium nitrate when a barge sank in the Mississippi in January 2016 (see above).

Finally, the organic matter category also significantly contributed to the overall total, representing 30%, due to a spill of 3,400 tonnes of liquid foodstuff (in this case molasses, spilt from a sugar factory) into a river in El Salvador (see above) (Fig. 4).

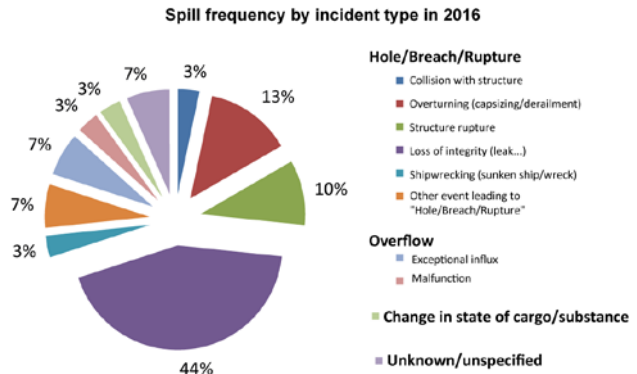
Figure 5

- The third type of event identified in terms of frequency (around 10% of all cases, see Fig. 5) was **structure ruptures** which did not represent a significant share of the total quantity spilt in 2016 either.

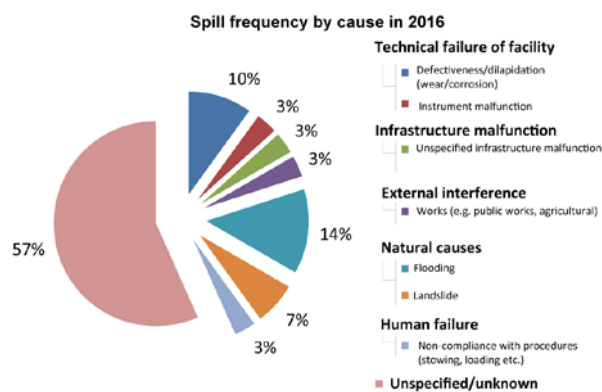
Figure 7

Technical failures of facilities caused around 13 % of events recorded (Fig. 7). The most frequent such incidents (10 %) were due to **defectiveness/dilapidation** of various elements (of onshore facilities and pipelines in 2016, etc.), although these incidents only represented a small share of the annual volume (Fig. 8).

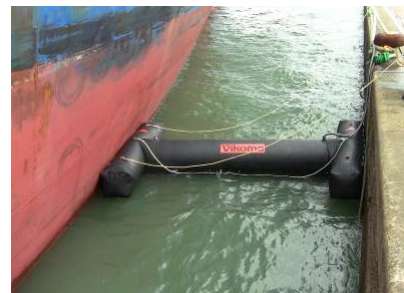
According to the manufacturer, the device has high abrasion resistance and high tensile strength (in particular resistance to towing and compression) – vital given the conditions in which it is used – thanks to its vulcanised neoprene. The draught of this boom is around 90 mm.

View of the VikoSeal deployed between a ship and the dock (Source: <https://www.vikoma.com/>)

The Vikoseal comes in 2 lengths, approximately 3 m and 4.5 m wide. In addition to its preventive role, as described above, the manufacturer claims that this device can be used in emergency response as a spacer for conventional booms deployed for instance around a grounded, leaking vessel (in order to provide a recovery/skimming area for floating substances).

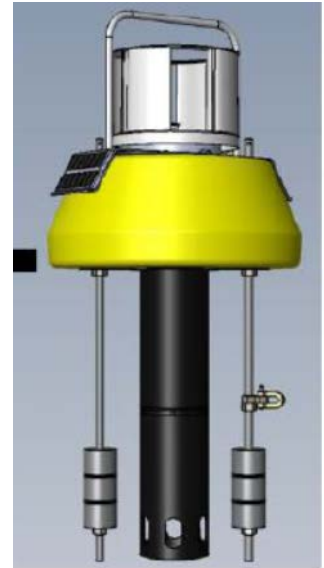
These buoys transmit the values of the parameters measured to a secure web portal which can be accessed by those concerned. According to requirements, a drop in one or more water quality parameters can be set to trigger an automatic alert by email or SMS, have a sample taken, a valve closed, etc. For more information on the equipment and services available, visit www.homeridersystems

Diagram of the buoy (Source: Veolia)

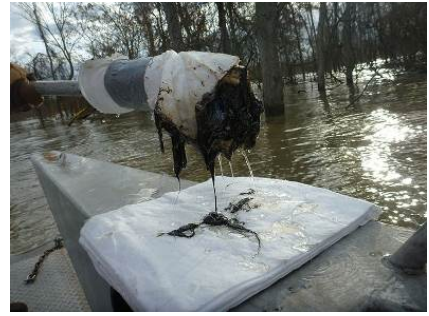
- on the bank, then flooded and with a slower flow rate where the leaking barge was moored, the presence of many submerged objects (structures, tree trunks, etc., not to mention the barge itself) prevented the detection of submerged oil using acoustic techniques. The oil was detected using an improvised system, made of long rigid tubes with sorbents wrapped around each end (dubbed a "cotton swab", see photo on the right), used to probe the submerged ground around the barge through the debris and vegetation.

An effective "low-tech tool" for detecting sunken oil (Source: NOAA)

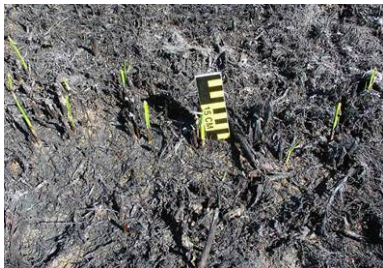
October 2005: Regrowth of the vegetation a few days after controlled burning operations.

Approved by the Unified Command, ISB was carried out for 2 days, a month and a half after the spill, with burns lasting 3 hours and 4.5 hours respectively, and resulted in the elimination of 90% of the oil according to NOAA. Signs of vegetation regrowth were observed very shortly after the burns, visible from a few days to a few weeks later according to the species.

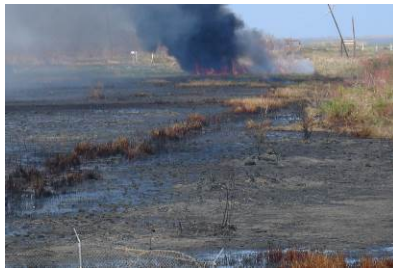
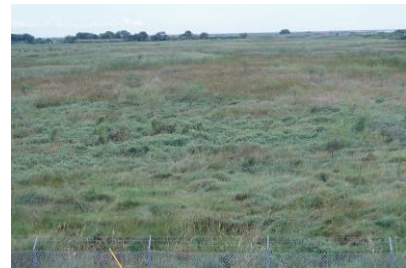
Comparative view of the oiled marsh following the spill caused by the damage to the Chevron storage facility due to the hurricanes of 2005: immediately after the burns (left) and 10 years later (right) (Photo source: NOAA)
