Pollution caused by

flooding in Île-de-France in 2016

Pollution caused by flooding in Île-de-France, in 2016

Response equipment
for use in strong currents

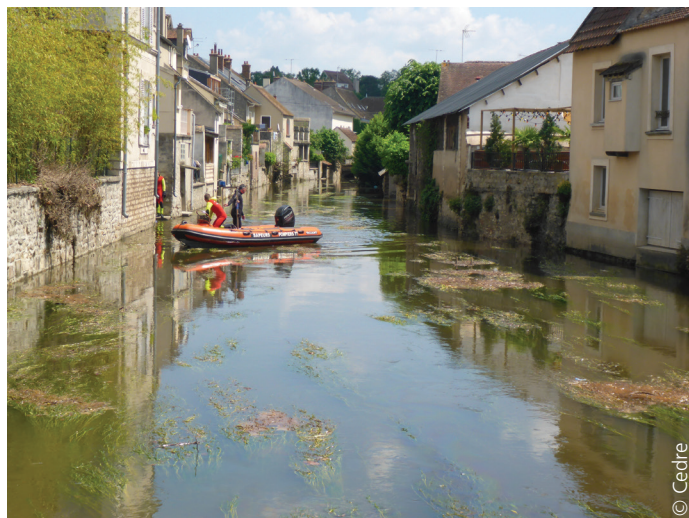
Conducting an on-water survey

spread along the watercourses, observe the containment systems deployed (mainly floating booms) and recommend alterations to optimise the set-up. Very soon, these investigations were further supported by surveys conducted on land, or even by boat when the streets were flooded. New recommendations on containment techniques and equipment were issued to support emergency response operations. In particular, they included advice on setting up custom-made barriers and filter systems, as conventional booms were unsuitable for certain sites.

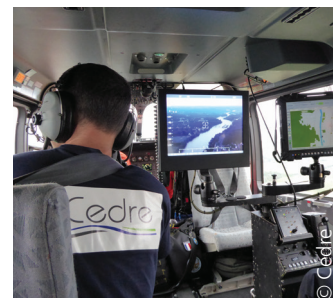
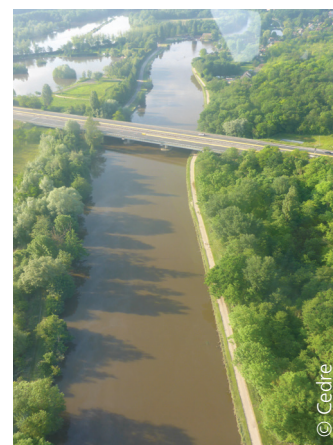
Aerial surveys

The pollution had spread very widely, carried by the flood waters as the water levels rose then fell. Helicopter overflights were conducted to monitor its

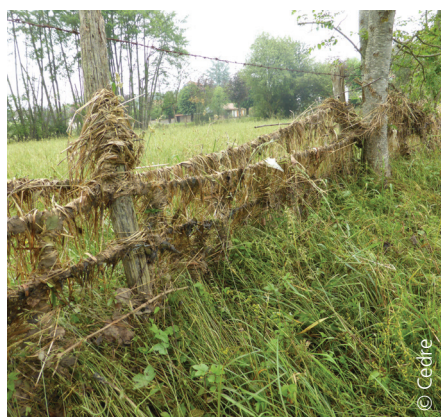
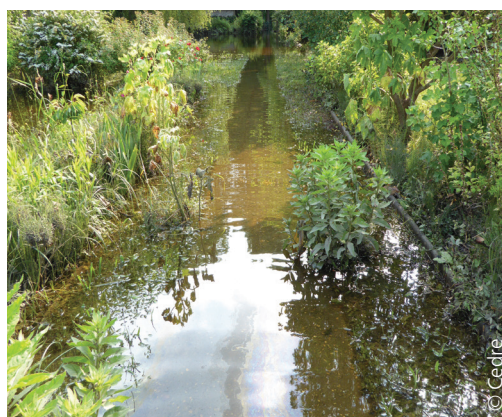
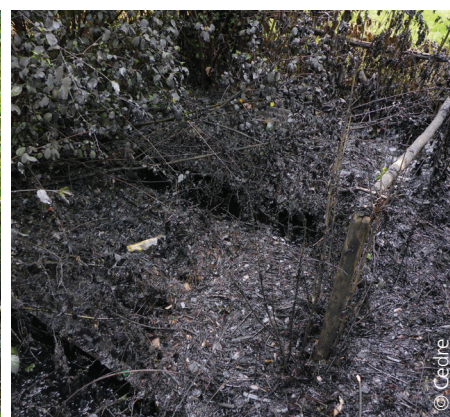
On land surveys

Many individual homes were affected by the oil, meaning that "door-to-door" visits had to be organised to obtain an accurate estimation of the extent of the pollution and to define *ad hoc* technical recommendations. These surveys were conducted jointly with the city councils and local authority staff, fire brigade personnel and other services.

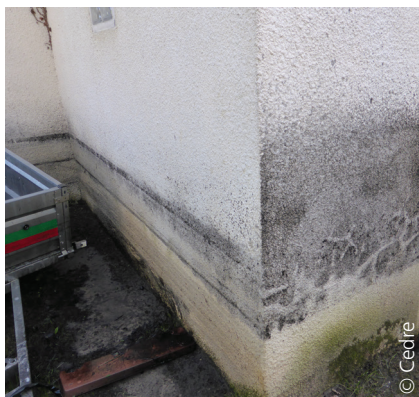
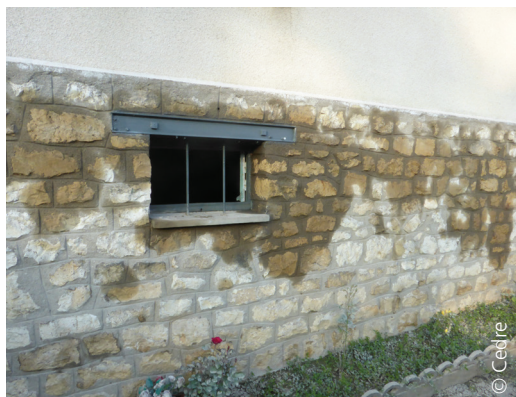
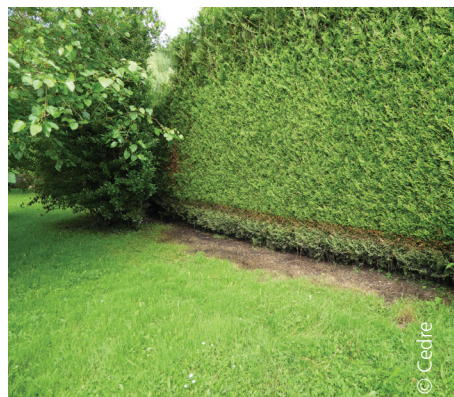
Polluted house walls and gardens

The pollutants observed were mainly light fuels, in particular diesel or home heating oil, as well as both new and used engine oil. Many other products present in cellars, sheds or workshops had also been released, although the exact type or quantity could not

In terms of the pollution deposited when the water level dropped, Cedre was questioned on the clean-up techniques to be implemented in homes and gardens, the equipment to be used and the available contractors. These recommendations were used to conduct clean-up, but also as supporting documents for insurance claims.

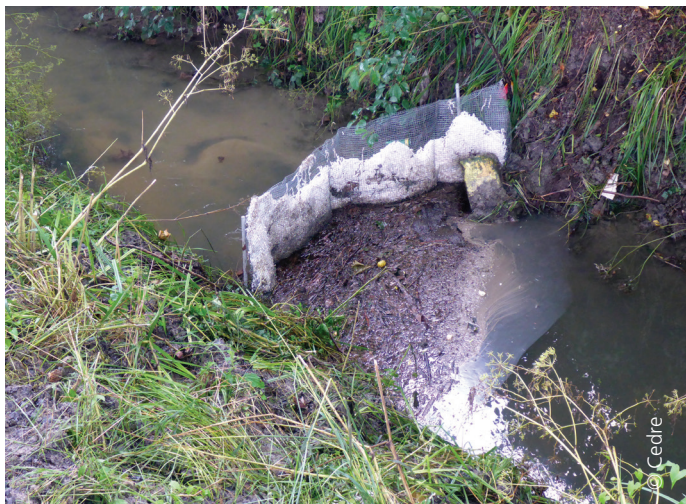
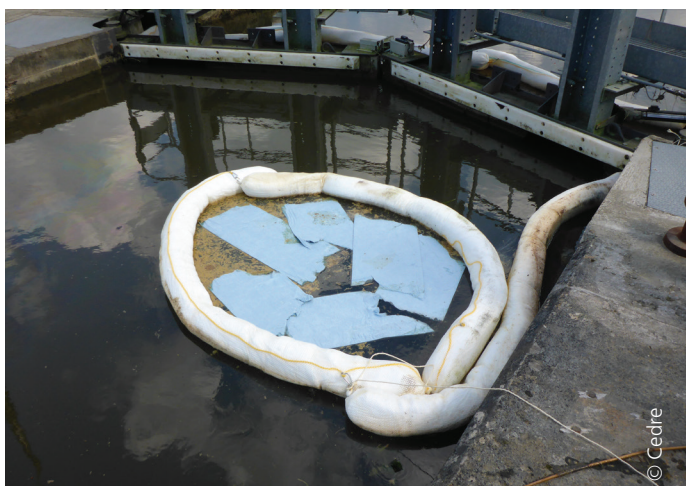
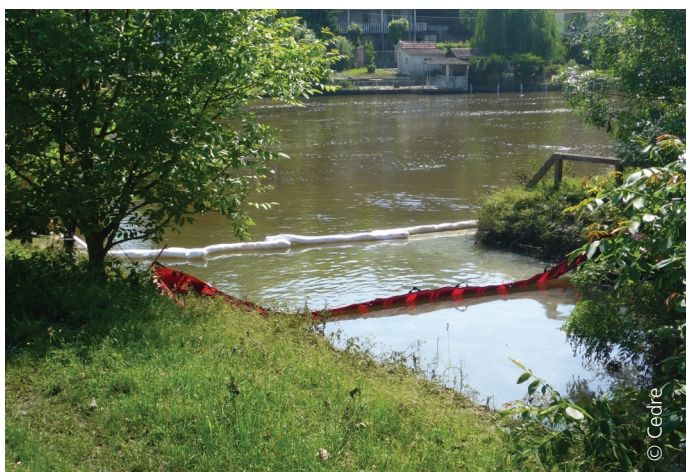
Booms and sorbents deployed on the water

Sorbent booms were also laid as "sentry" devices, or near to points of pollution resurgence, or else in a protective capacity for certain sites.

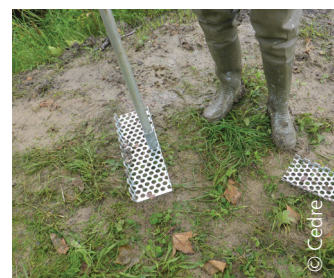
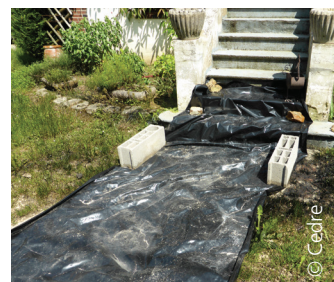
Cleaning up contaminated gardens

The techniques recommended for gardens are similar to those used during the "botanical clean-up operations" implemented in oiled natural vegetated areas: scything, selective cutting, scraping, or even removal of a few centimetres of soil. In terms of the clean-up of hard surfaces, the emphasis was on the urgent need to contain, recover and treat washing effluents.

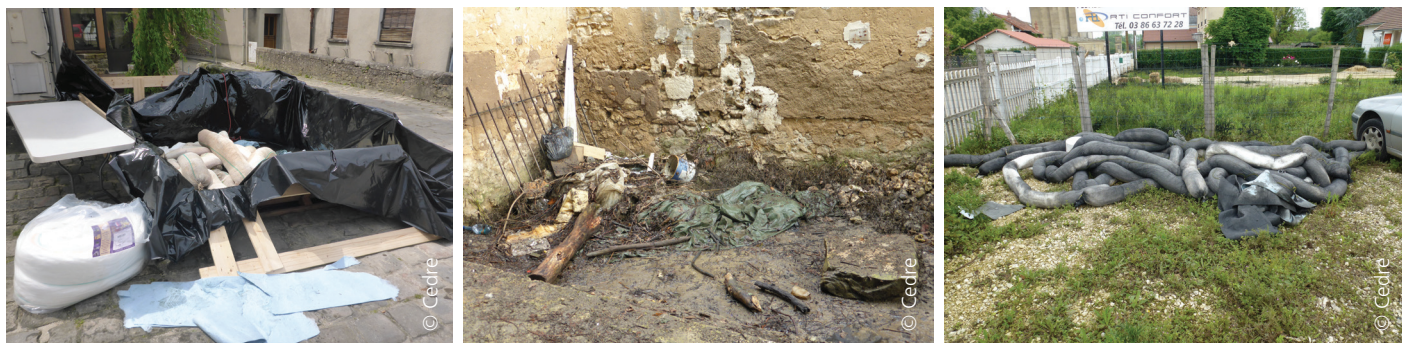
Disparate management of oiled waste

Very quickly, the quantity of sorbents required, and their installation, surveillance, renewal and treatment once oiled became an issue in itself. This came in addition to the problem of storing and processing the large quantities of litter and debris, whether oiled or not, generated by the flooding. Improvised storage areas were set up locally, sometimes in very restrictive conditions given the complex circumstances. In certain cases no ground protection was laid, creating a risk of secondary contamination.

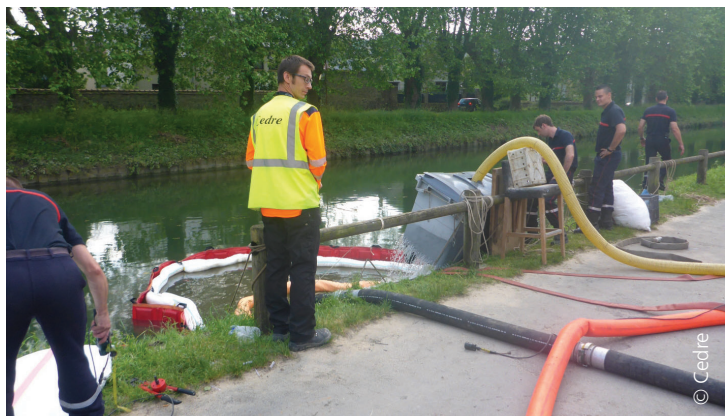
Filter bins (Cedre - Fire and Rescue Service) on 8th June 2016

Another urgently needed action was to pump the large volumes of contaminated water out of flooded sites (cellars, underground car parks). Cedre assisted the Seine-et-Marne Fire and Rescue Service in designing and building makeshift filtration systems made of bins with a perforated base and filled with loose sorbent. These systems were used to evacuate the water from these sites and release it into the natural environment. Technical datasheets were also produced by Cedre and distributed.

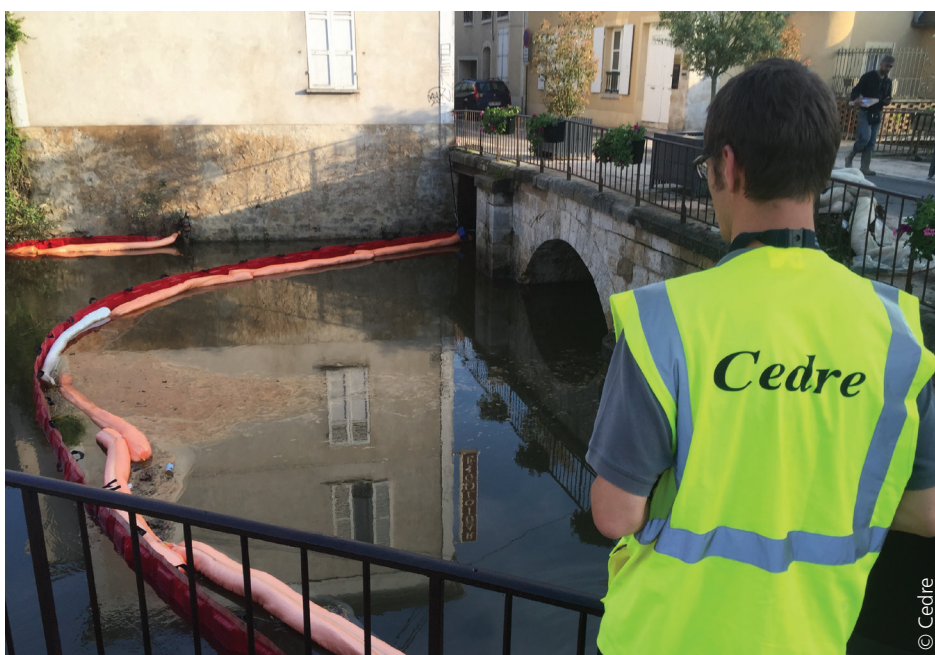
Survey by the Fire and Rescue Service and Cedre in Nemours on 6th June 2016

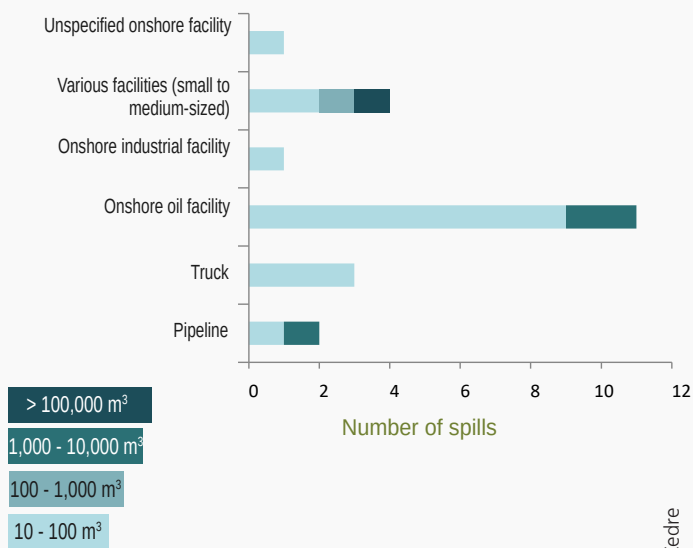
NUMBER OF SPILLS BY SOURCE STRUCTURE TYPE

oil facilities. Around 70% of incidents reported in 2017 were due to holes, breaches or ruptures in various structures.

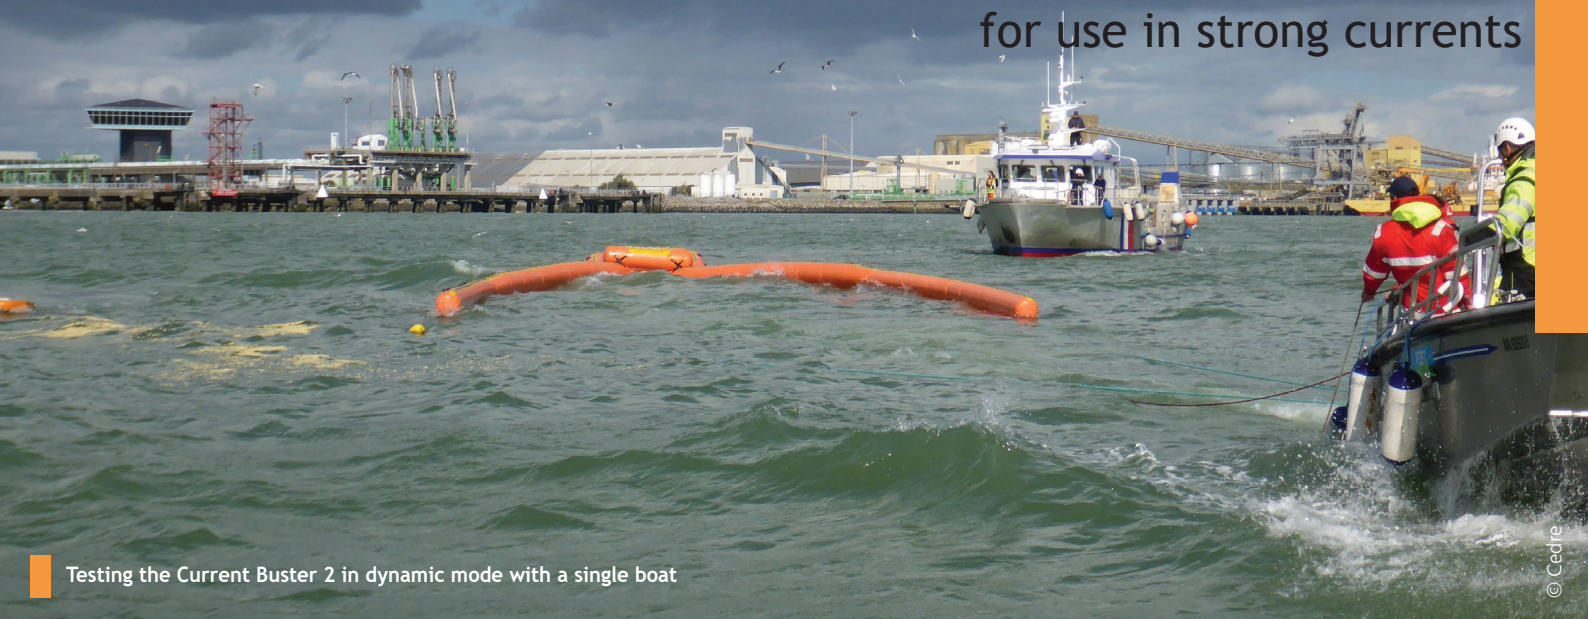
Testing the Current Buster 2 in dynamic mode with a single boat

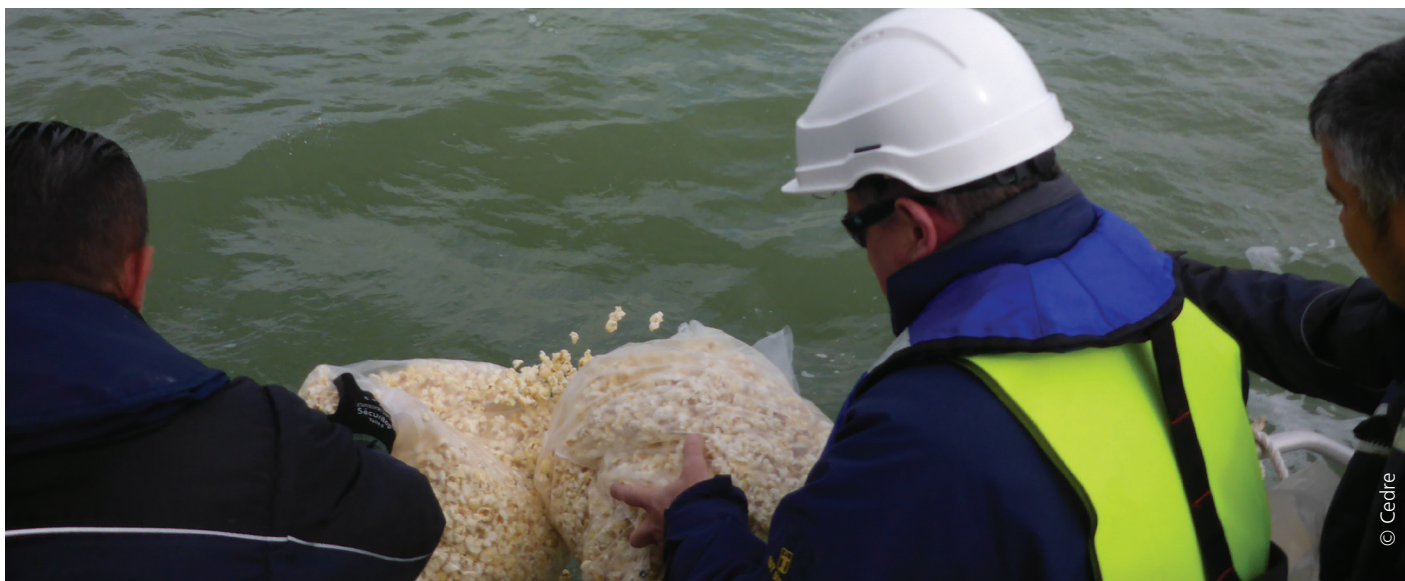
Slick simulation: releasing popcorn from Cedre's boat

For environmental reasons, no oil could be released in the Loire estuary during the trials. Popcorn and oranges were used to visualise the behaviour of a floating pollutant in the systems tested. When released onto water, popcorn floats, simulating a slick, for long enough to carry out the necessary observations. Popcorn is biodegradable and was considered to have a negligible environmental impact in the trial conditions.

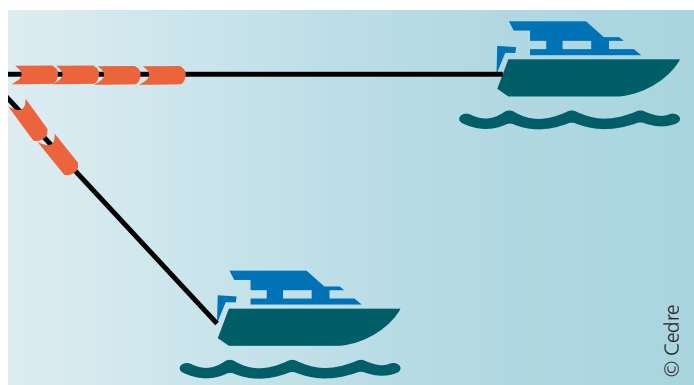
Diagram illustrating deployment by a pair of boats

The aim of the first series of dynamic trials was to assess the manoeuvrability and collection capacity of each system when towed by a pair of vessels.

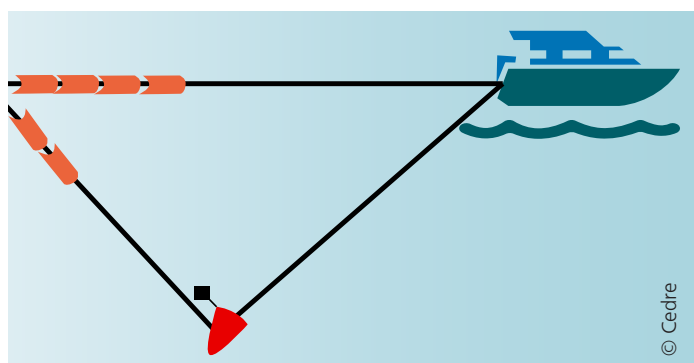
Diagram illustrating deployment by a single boat

The aims of this second series of trials consisted in assessing the manoeuvrability and collection performance of each system towed by a single boat assisted by a paravane equipped with vertical wings which force the paravane to move away from the vessel, while keeping the towing wire taut.

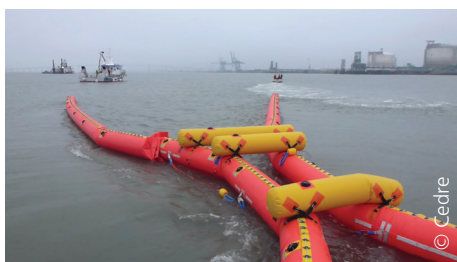
Operating the Current Buster 4 in dynamic mode with two boats

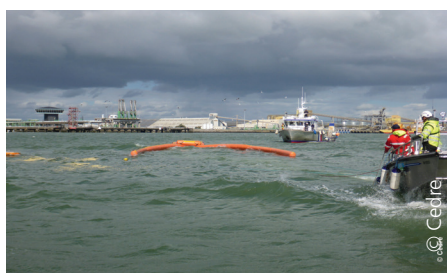
Testing the Current Buster 2 in dynamic mode with a single boat

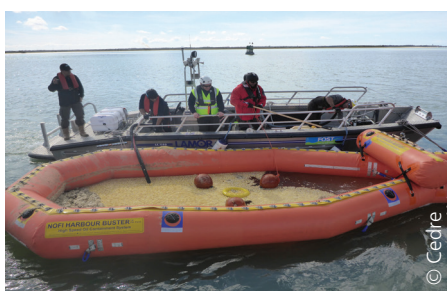
Skimming the simulated spill in the apex of the Current Buster 2 and transfer to the floating storage capacity

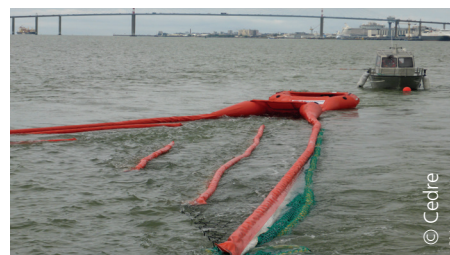
Dynamic trial with the LMOS Sweeper 15 with two boats

These two systems gave good results in terms of decreasing the flow rate in the collector pool, meaning that they are able to work effectively well beyond the limits of conventional booms, at around 3.1 knots in optimal conditions for the Speed Sweep and 3.5 knots for the LMOS Sweeper 15. The efficiency of these systems will therefore tail off at just over 3 knots, a current speed frequently encountered in estuaries.
